Product Safety Recall

Hollowtech cranksets for certain Shimano Ultegra and Dura-Ace models

PRA2023/19944

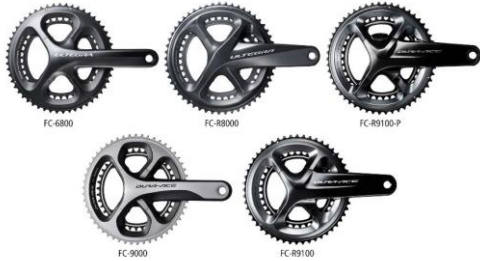
11-speed bonded Hollowtech II road cranksets, suitable for certain Ultegra and Dura-Ace models, manufactured between 1 June 2012 – 1 July 2019.

Why the product is recalled: The bonded crank parts can separate and break, causing the crank arm to separate from the main crank arm-body.

Hazard: There is a risk of a fall or crash if the crank arm separates. At the time of publishing, Shimano has received 4,519 incidents of cranksets separating, and six reported injuries, including bone fractures, joint displacement and lacerations.

Consumers should not use a bike with Shimano Ultegra or Dura-Ace cranksets until they check if theirs is an affected model. Instructions on how to check are on the [Shimano website](#).

If you have an affected model, contact the nearest authorised Shimano dealer to arrange for the cranksets to be inspected. Any cranksets that fail the inspection process will be replaced free of charge.
