### ELECTRICAL SAFETY RECALL

## Spa Quip 800 Spa Controller Spa Quip 1200 Spa Controller

Models: Q800-30, Q800-30LAN, Q800-30R, Q1200-35, Q1200-35R, Q1200-45, Q1200-45R and Q1200-60.

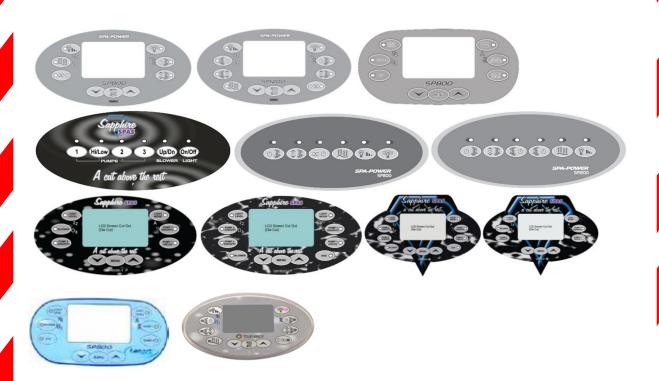
The controller is part of the inner workings of the spa and will be found behind the spa's cabinet or under decking adjacent to the spa. The exact location of the controller will vary depending on the spa design. The simplest way to identify whether a spa is affected by this recall is to look at the spa's touchpad design. Spas with touchpads similar to those in the photographs below may contain an affected controller. If unsure, consumers can email a photograph of their spa touchpad to <a href="mailto:SpaQuipRecall@davey.com.au">SpaQuipRecall@davey.com.au</a> and a team member will confirm if it is an affected spa.

If affected, consumers should disconnect / isolate, and stop using the spa. Do not undertake any repairs or connect any new devices to the spa and contact Davey Water Products to arrange for a free replacement controller to be fitted to the spa by a certified technician, free of charge.
